APPENDIX D: HISTORICAL AERIAL PHOTOGRAPHS

A series of historical photographs was prepared by Walker & Associates for the project site vicinity; photographs from 1936, 1946, 1956, 1960, 1969, 1974, and 1980 are included. These photographs were enlarged to a scale of 1 in:150 ft to show site-specific details. They were scanned at high resolution, and the images were then cropped and labeled to indicate the location of present-day T-117. The following observations were based on viewing the full extent of each photograph, so some of the outlying features discussed are not visible. The full scanned images are available on request; files range in size from 5–8 MB.

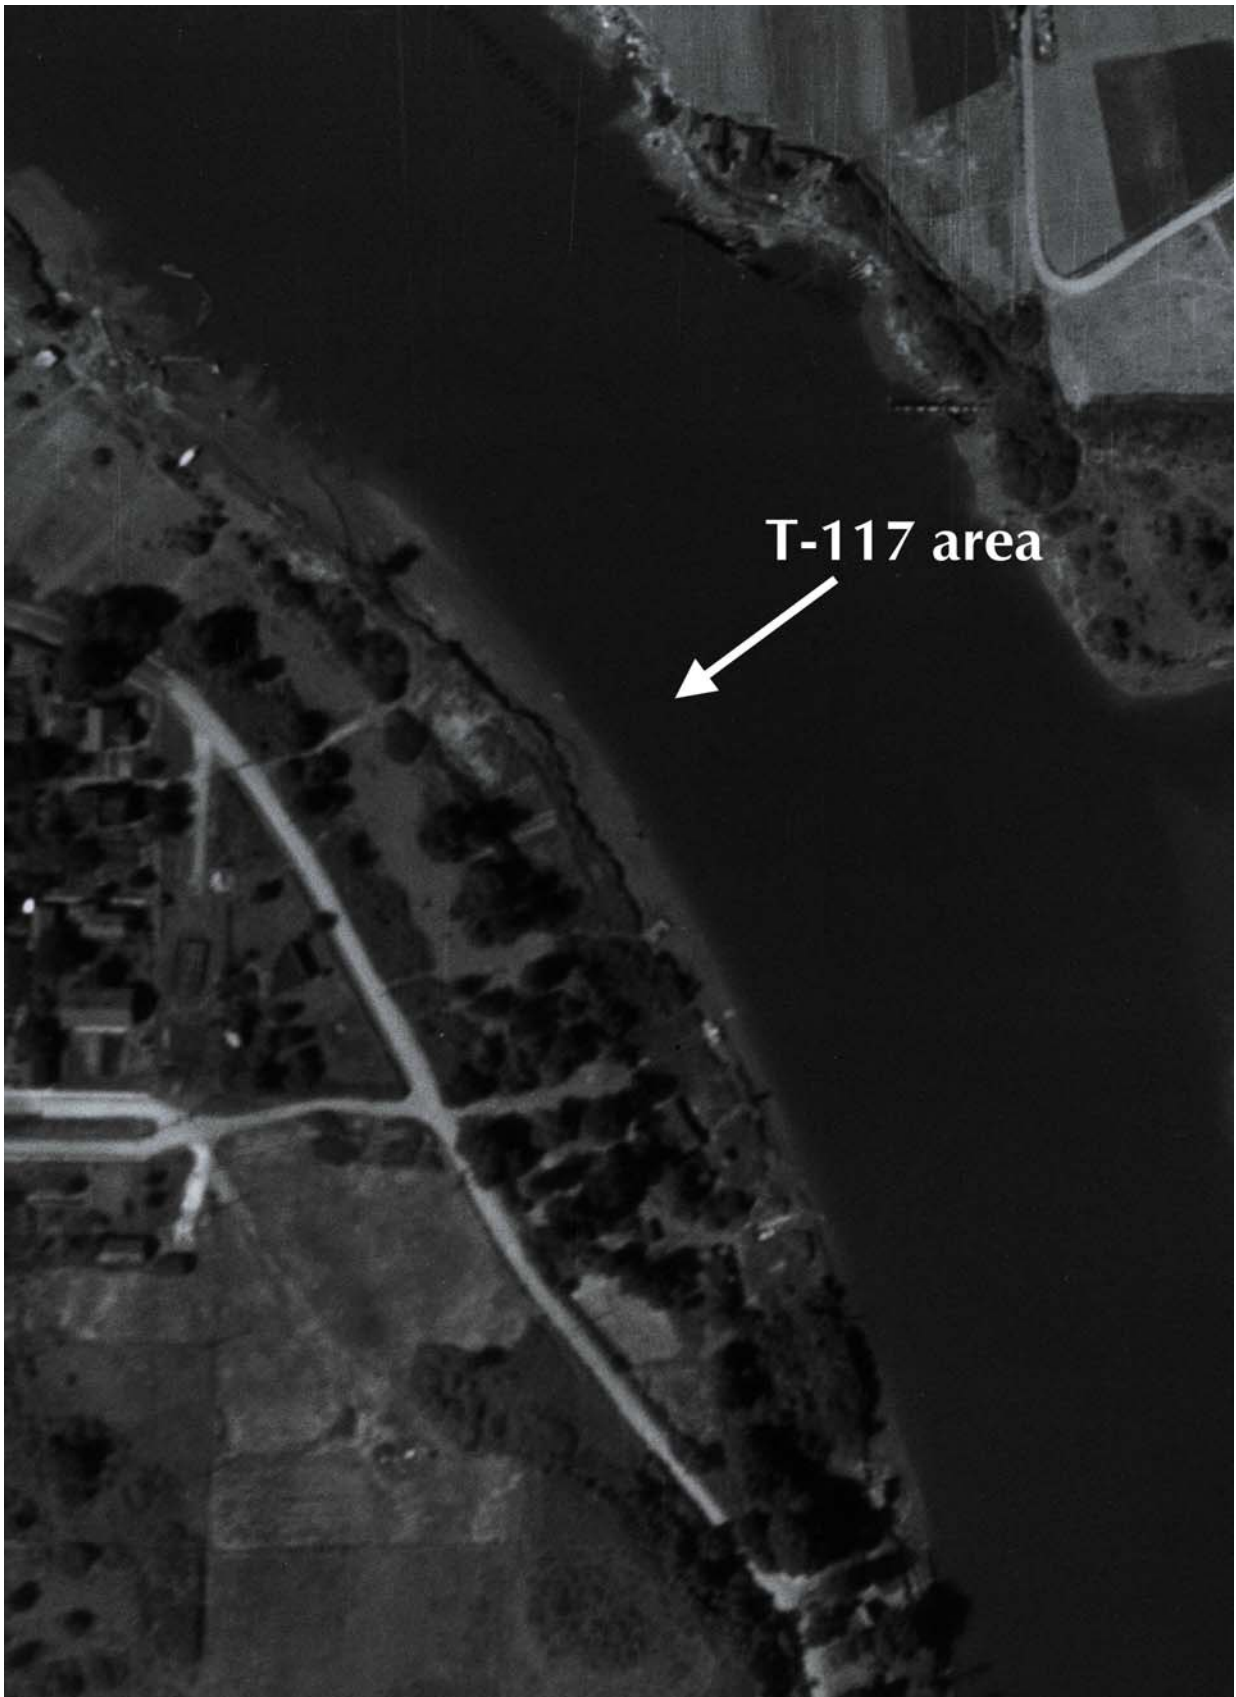
1936

16th Ave S and the South Park Bridge are clearly visible in this photograph, as are Dallas Ave S, and 16th Ave S. Only a portion of 17th Ave S is visible where it intersects with Dallas Ave. Donovan St is present, and Dallas Ave can be observed extending down the west shoreline area of the river. Residences can be seen on the parcels between 16th and 17th Ave S. There is no evidence of industrial activities within the study area. The land east of Dallas Ave is undeveloped, and trails can be seen extending east to the river shoreline. An inland ridge can be seen running parallel to the river alignment. This ridge may be the former “cut line” for the river channel, or it could be earlier fill deposited on the upland areas in prior years. A bench can be observed between this line and the shoreline tide flats that may consist of dredged fill placed during the early 20th century.

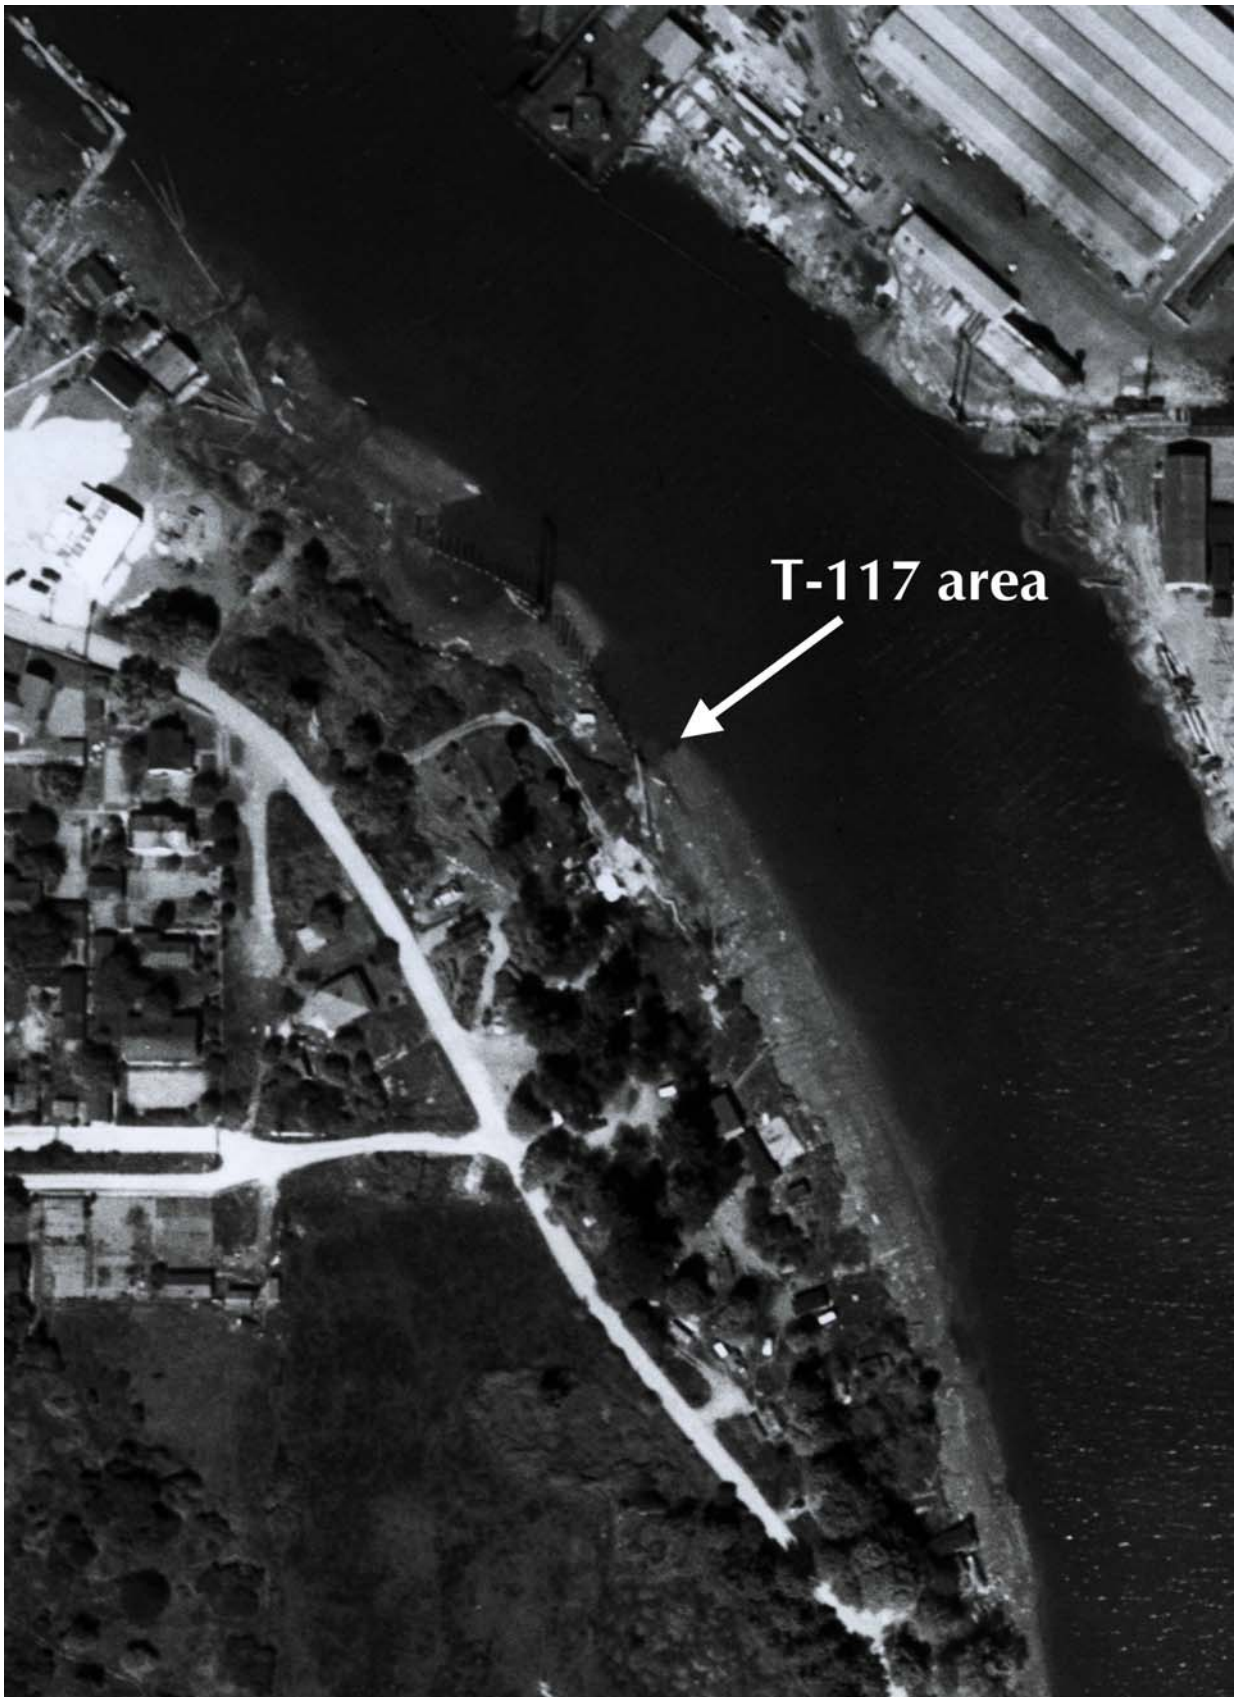
1946

In contrast to the 1936 photograph, this photo shows evidence of industrial activities beginning on the properties east of Dallas Ave. Mobile homes can be observed in the north portion of the present-day location of South Park Marina, and the beginning of a boat dock can be seen extending into the river. New roadways are present in the T-117 vicinity. A building corresponding with the location of A-B Barrel Company can be seen in the boatyard area. Limited clearing and grading can be observed south of the present-day Boeing South Park plant location. Of particular interest are the structures and shoreline modifications along the riverbank. A row of piles can be observed in the vicinity of the shoreline power pole structure, and additional sediment has accumulated in the intertidal area. Several cuts into the intertidal area (dredged areas) can also be observed. Unidentified structures (boathouses) can be seen on the shoreline in the boat yard and mobile home park shoreline areas.

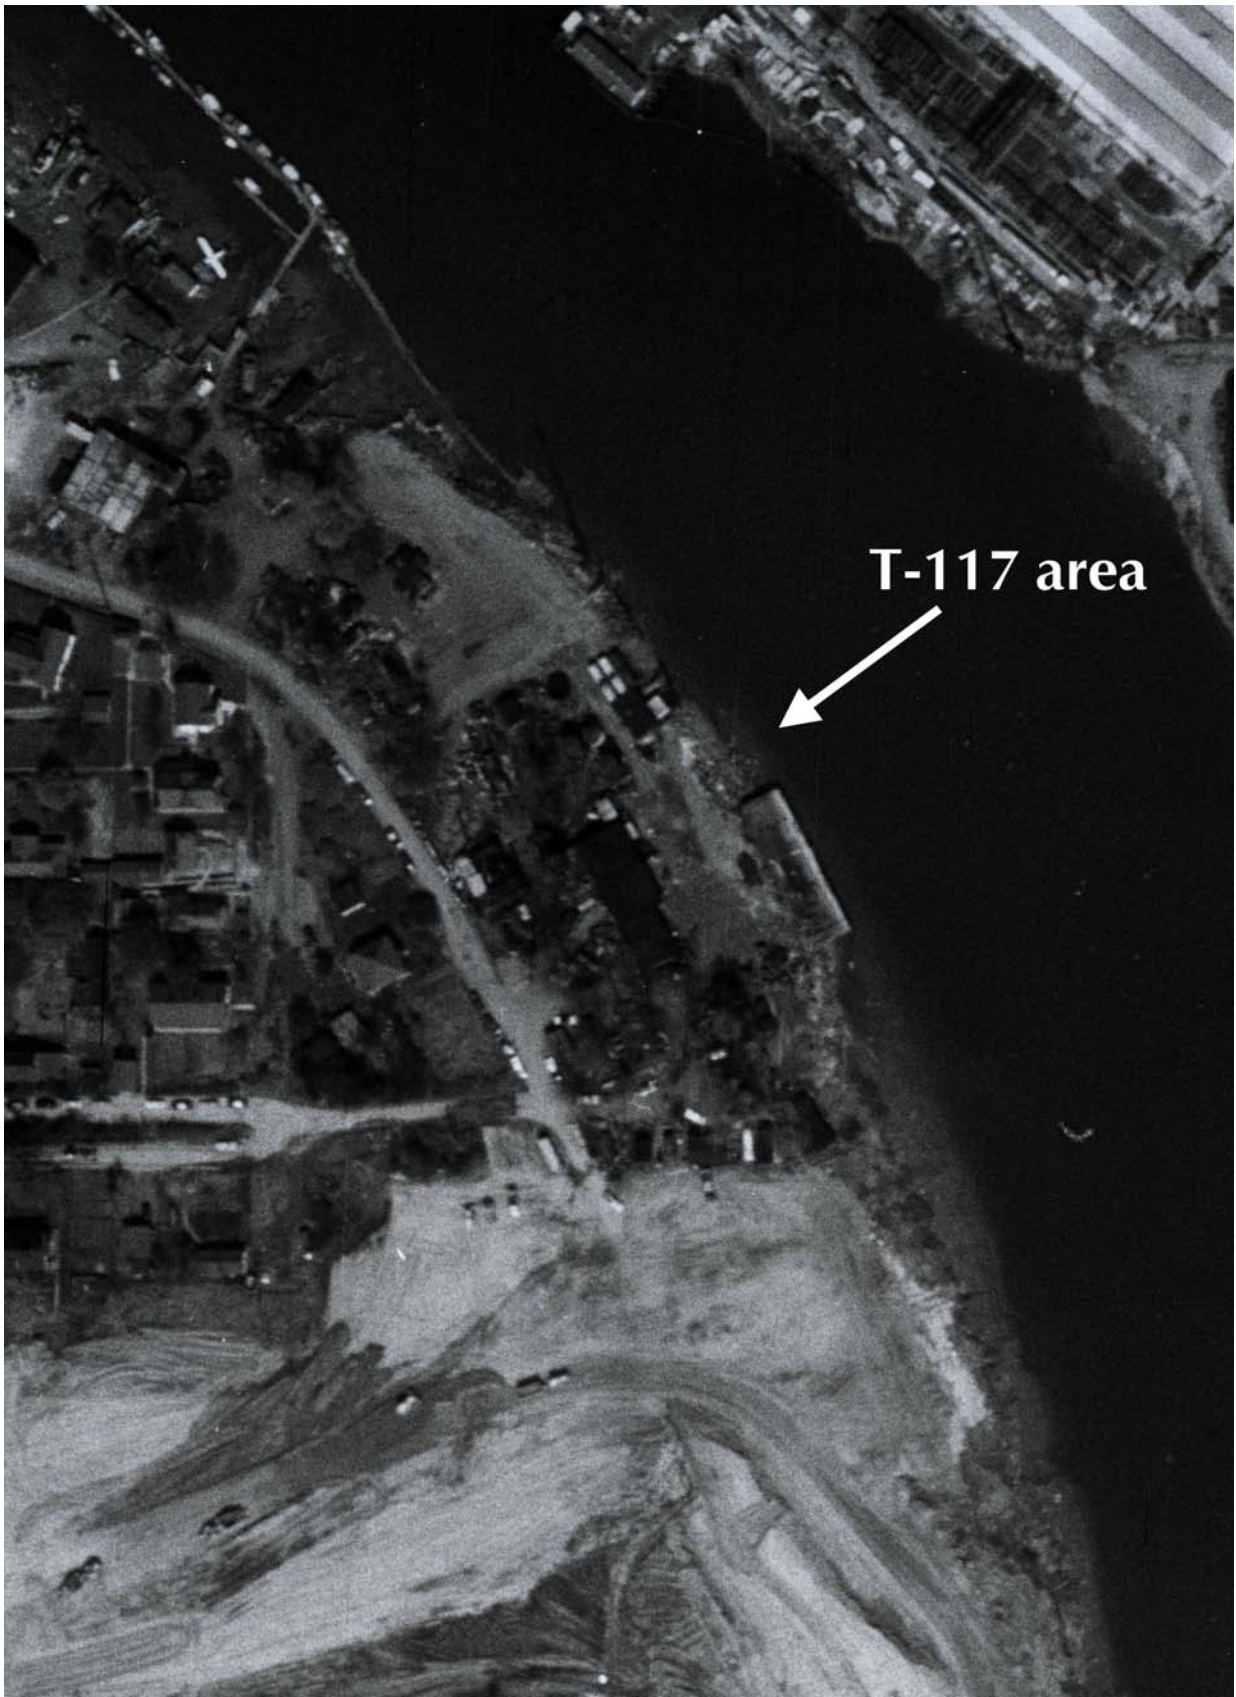
1956

This photo shows evidence of extensive filling in the T-117 vicinity. Recent graded fill can be observed in north portion of the future terminal area and extends out to the piling noted in the 1946 photo. Structures and tanks associated with the Duwamish Manufacturing Company are readily apparent. Dallas Ave terminates at Donovan St; the area to the south is occupied by a huge earthmoving/grading project in the present-day vicinity of Boeing South Park. The Basin Oil Plant vicinity is still occupied by several residential structures.

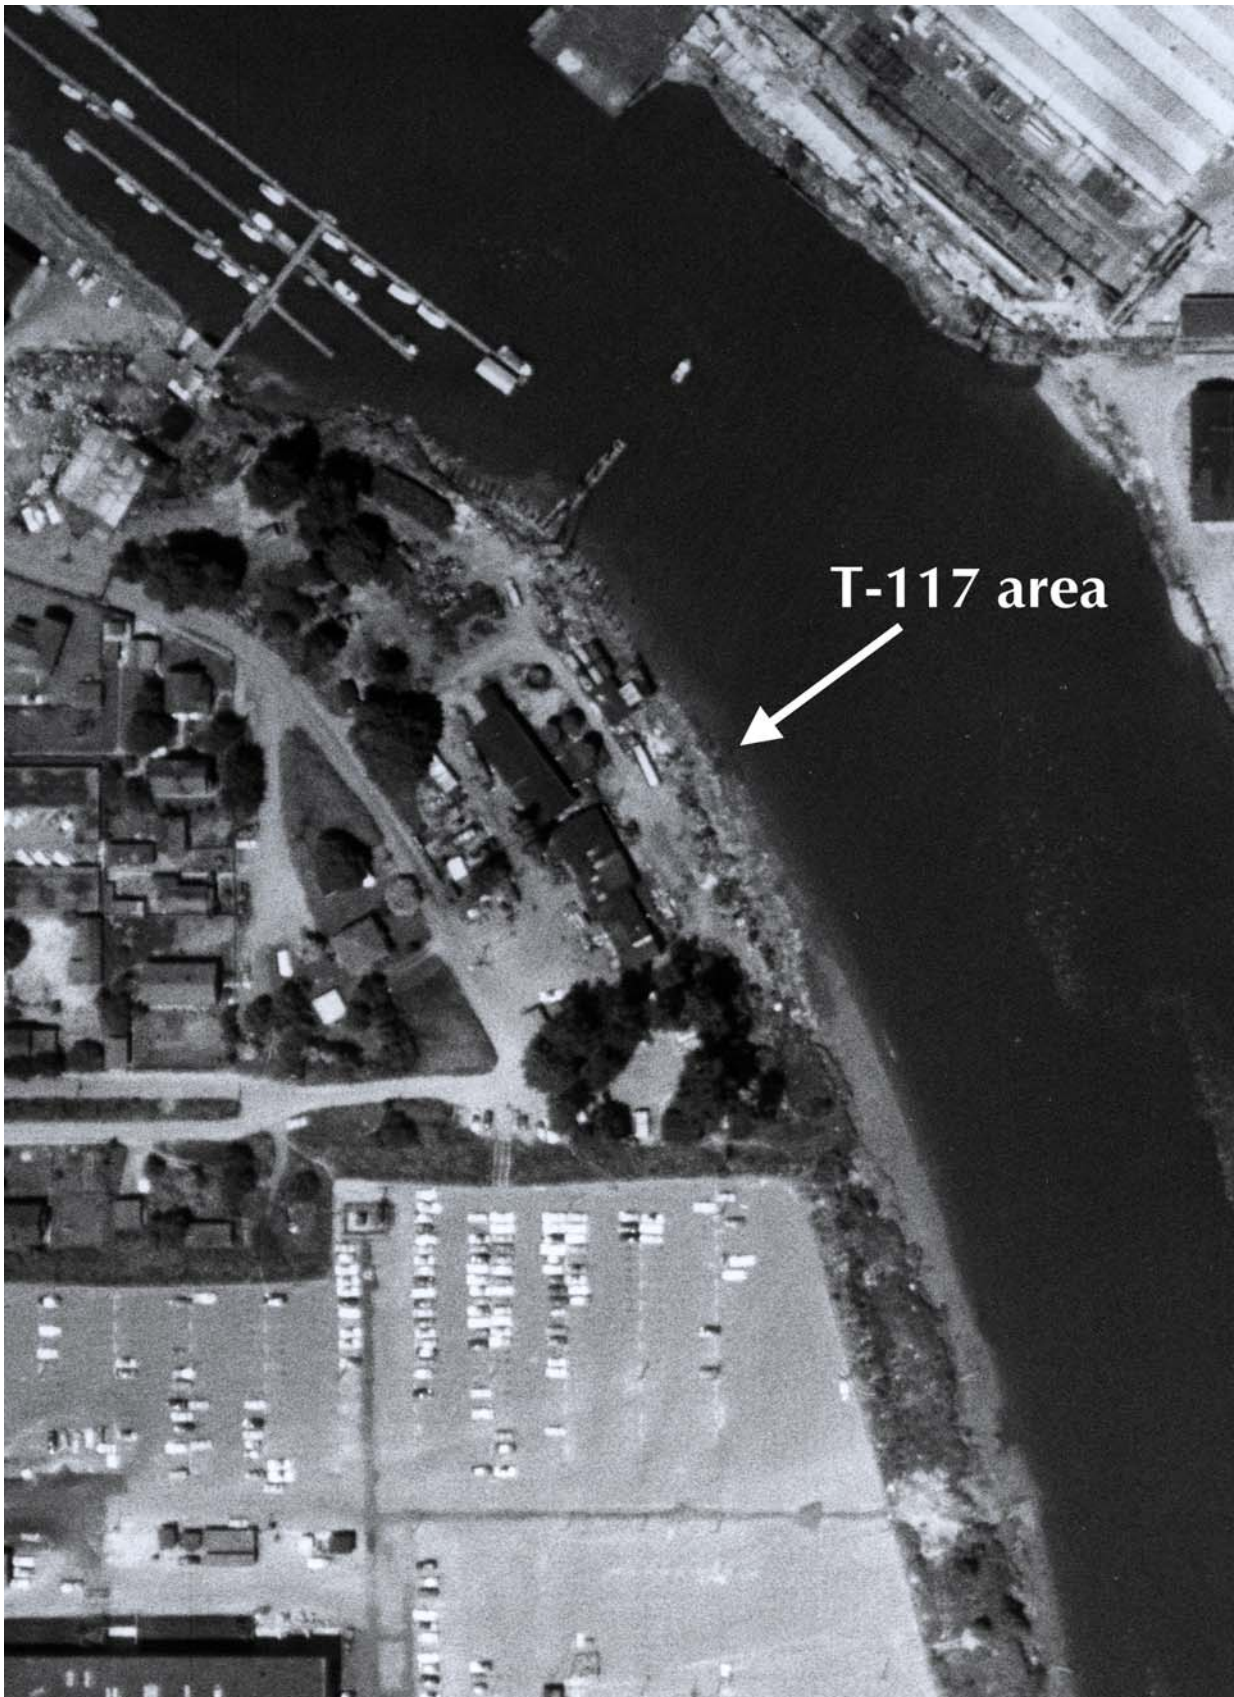
1960

This photo shows the site beginning to take on its modern configuration. The South Park Boat Haven operation is clearly visible and the mobile home park is still operating at the north end of the study area. Additional warehouse or plant structures are present at the Duwamish Manufacturing Co. location. The Boeing South Park area is paved and a large building is located on the west-central portion of the site. The Basin Oil vicinity still appears to be primarily residential. The roadway “pond” feature is visible in the roadway at the east side of T-117. A small, possibly commercial structure can be observed at the south end of 17th Ave S (north of Donovan Rd) at the eventual location of Allied Bolt Co.

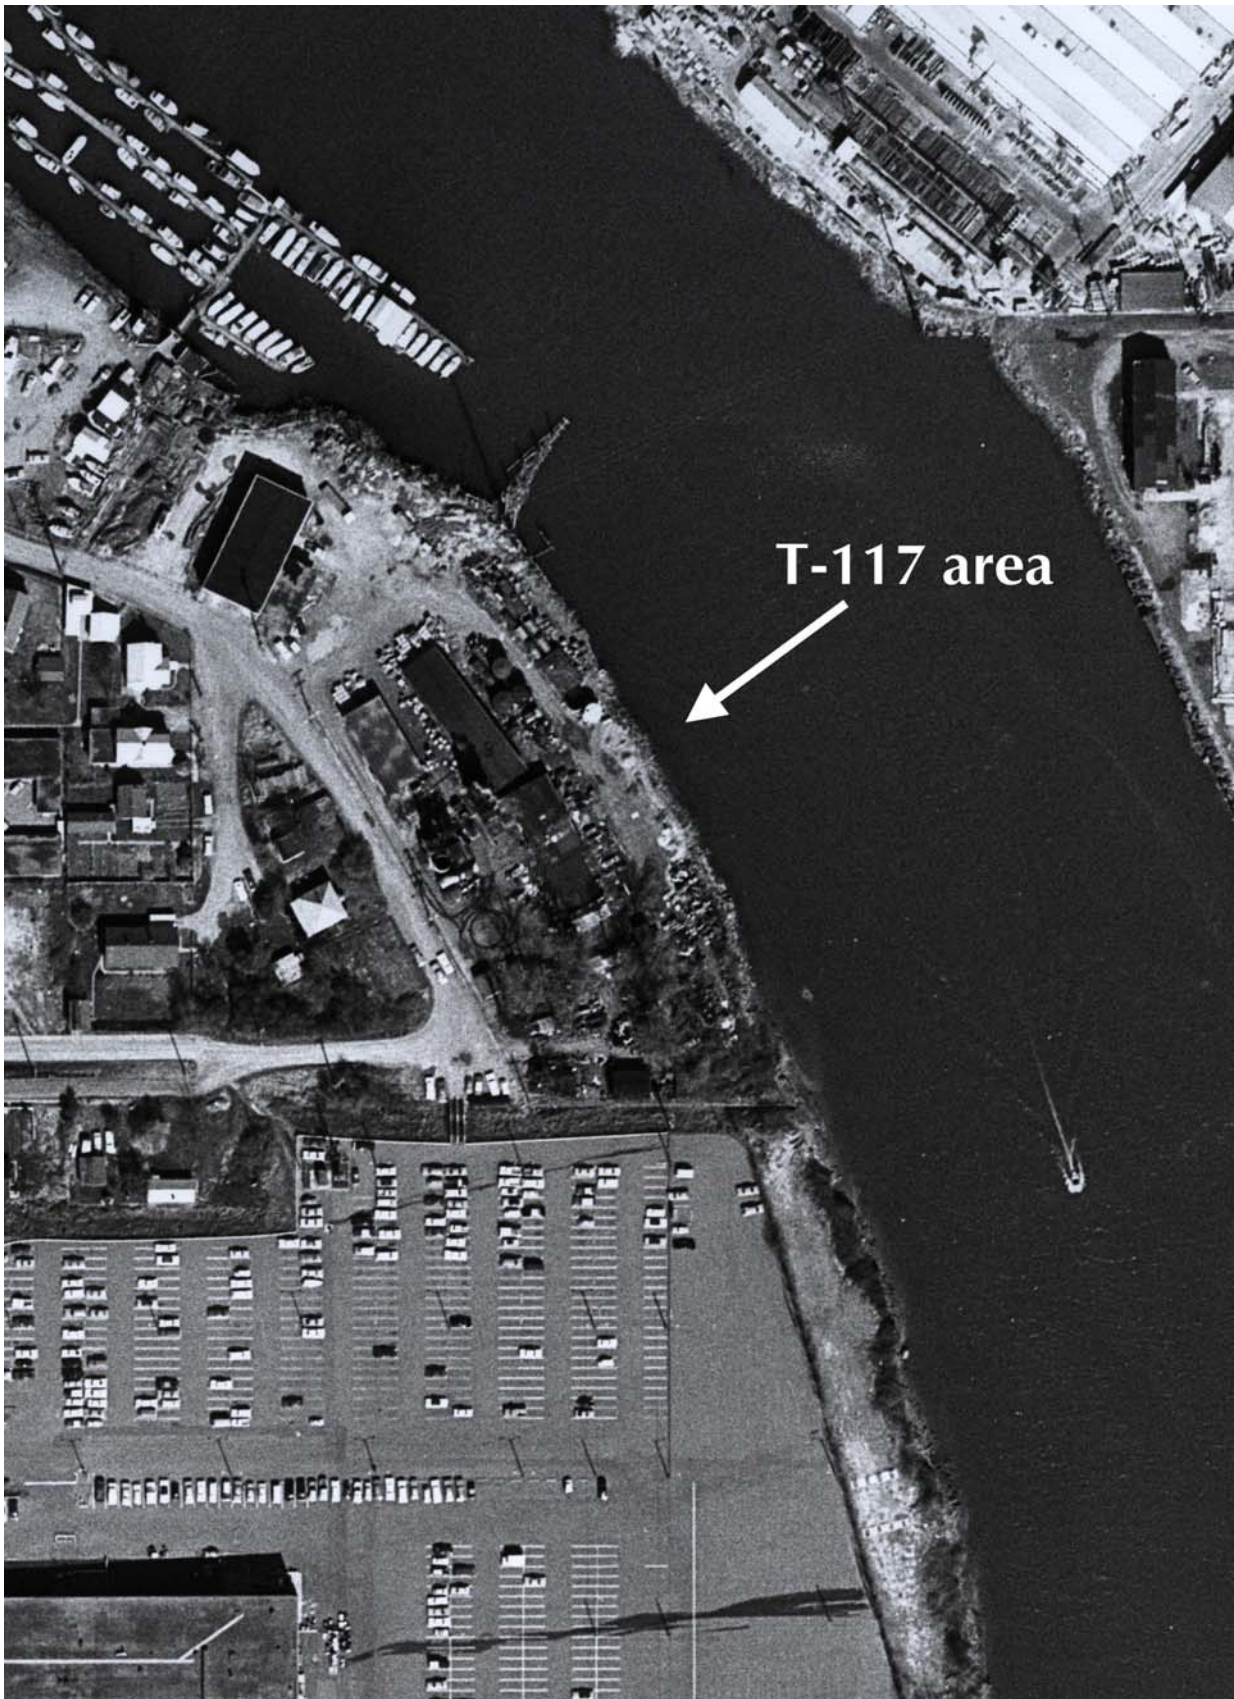
1969

Features are similar to the 1960 photograph. An additional building is present at the Boeing South Park location. There is a pronounced drainage ditch at the south side of the present-day T-117 property, extending from the south terminus of Dallas Ave east to the river. A small building is located on the north side of this ditch. Also, the north office building (present location of International Inspection) at T-117 is present. The vicinity of Basin oil still appears to be primarily residential. The shoreline area appears to have a rip-rap texture.

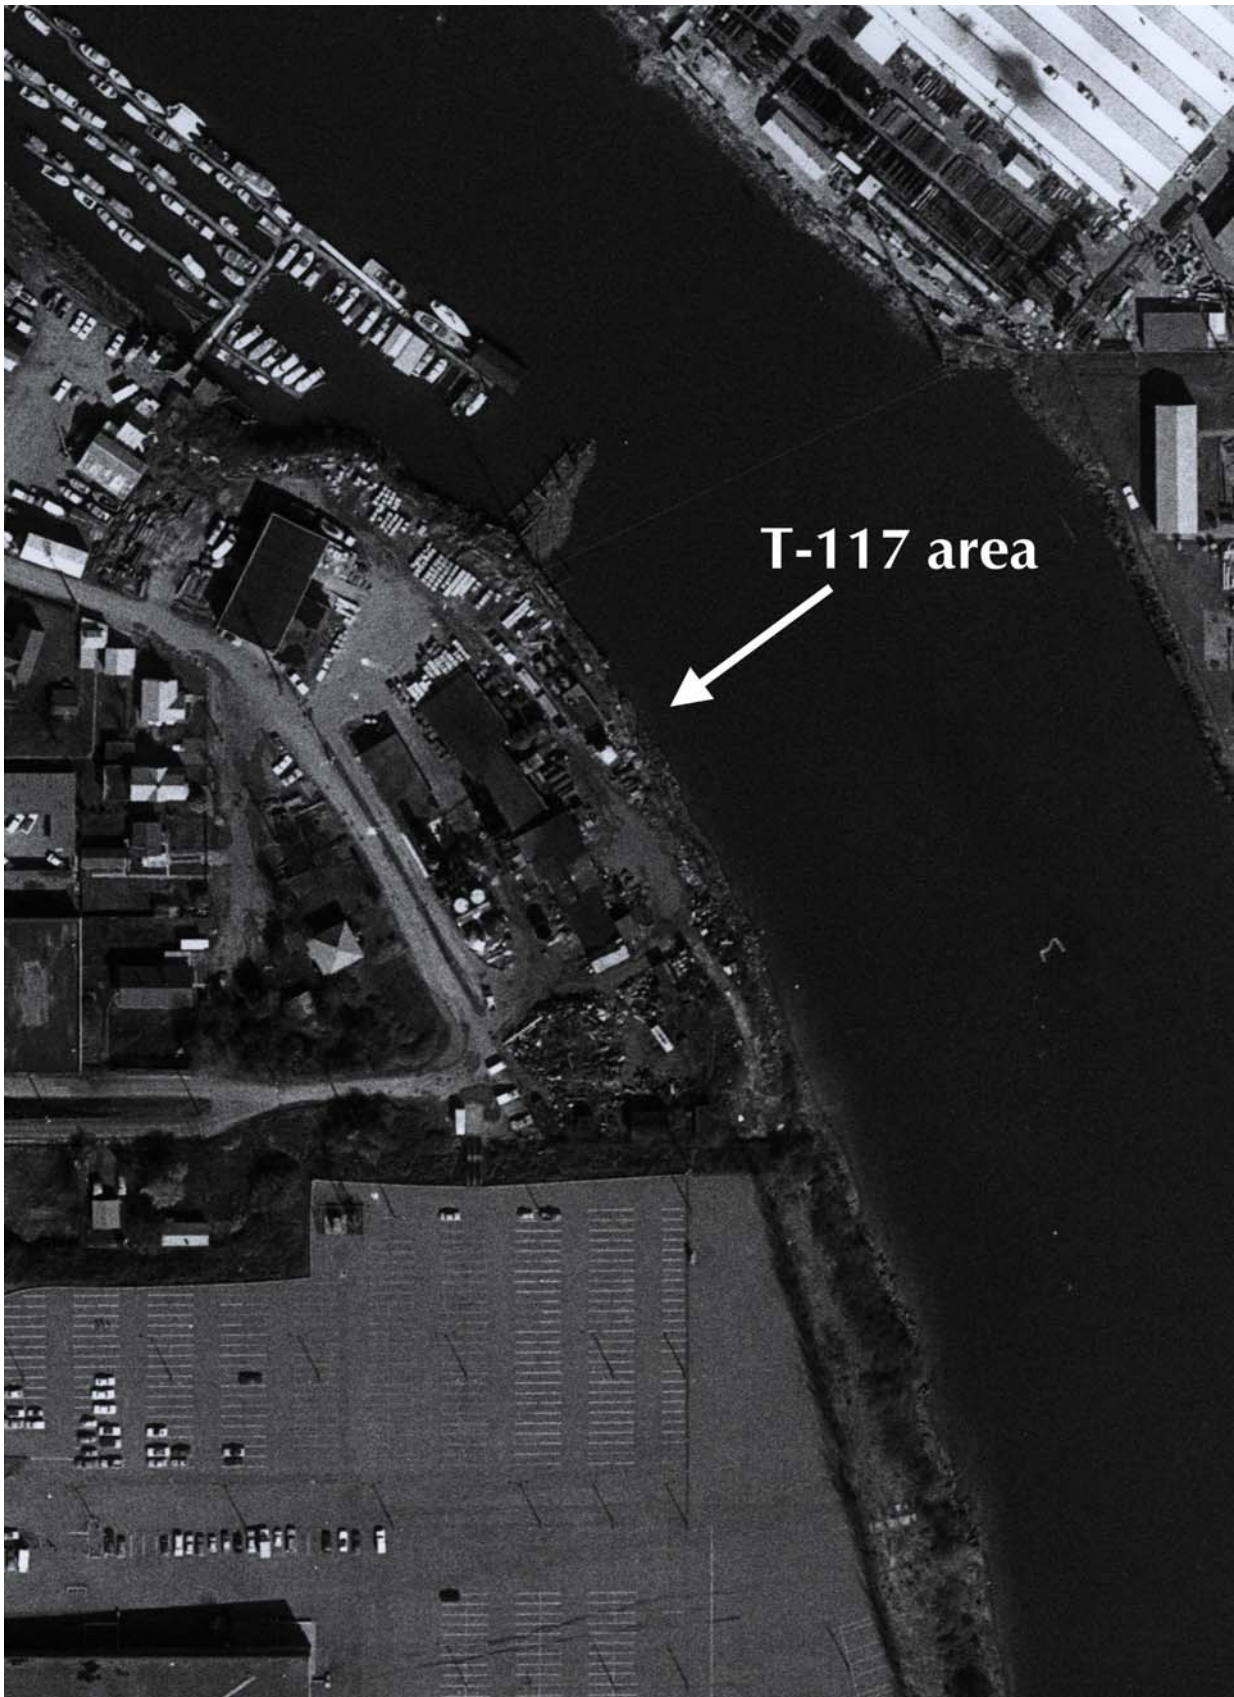
1974

There is little change from the 1969 features. Several new tanks can be seen in the Duwamish Manufacturing plant area. A new commercial structure is evident at the northeast corner of Donovan St and 16th Ave S, possibly associated with Allied Bolt Company.

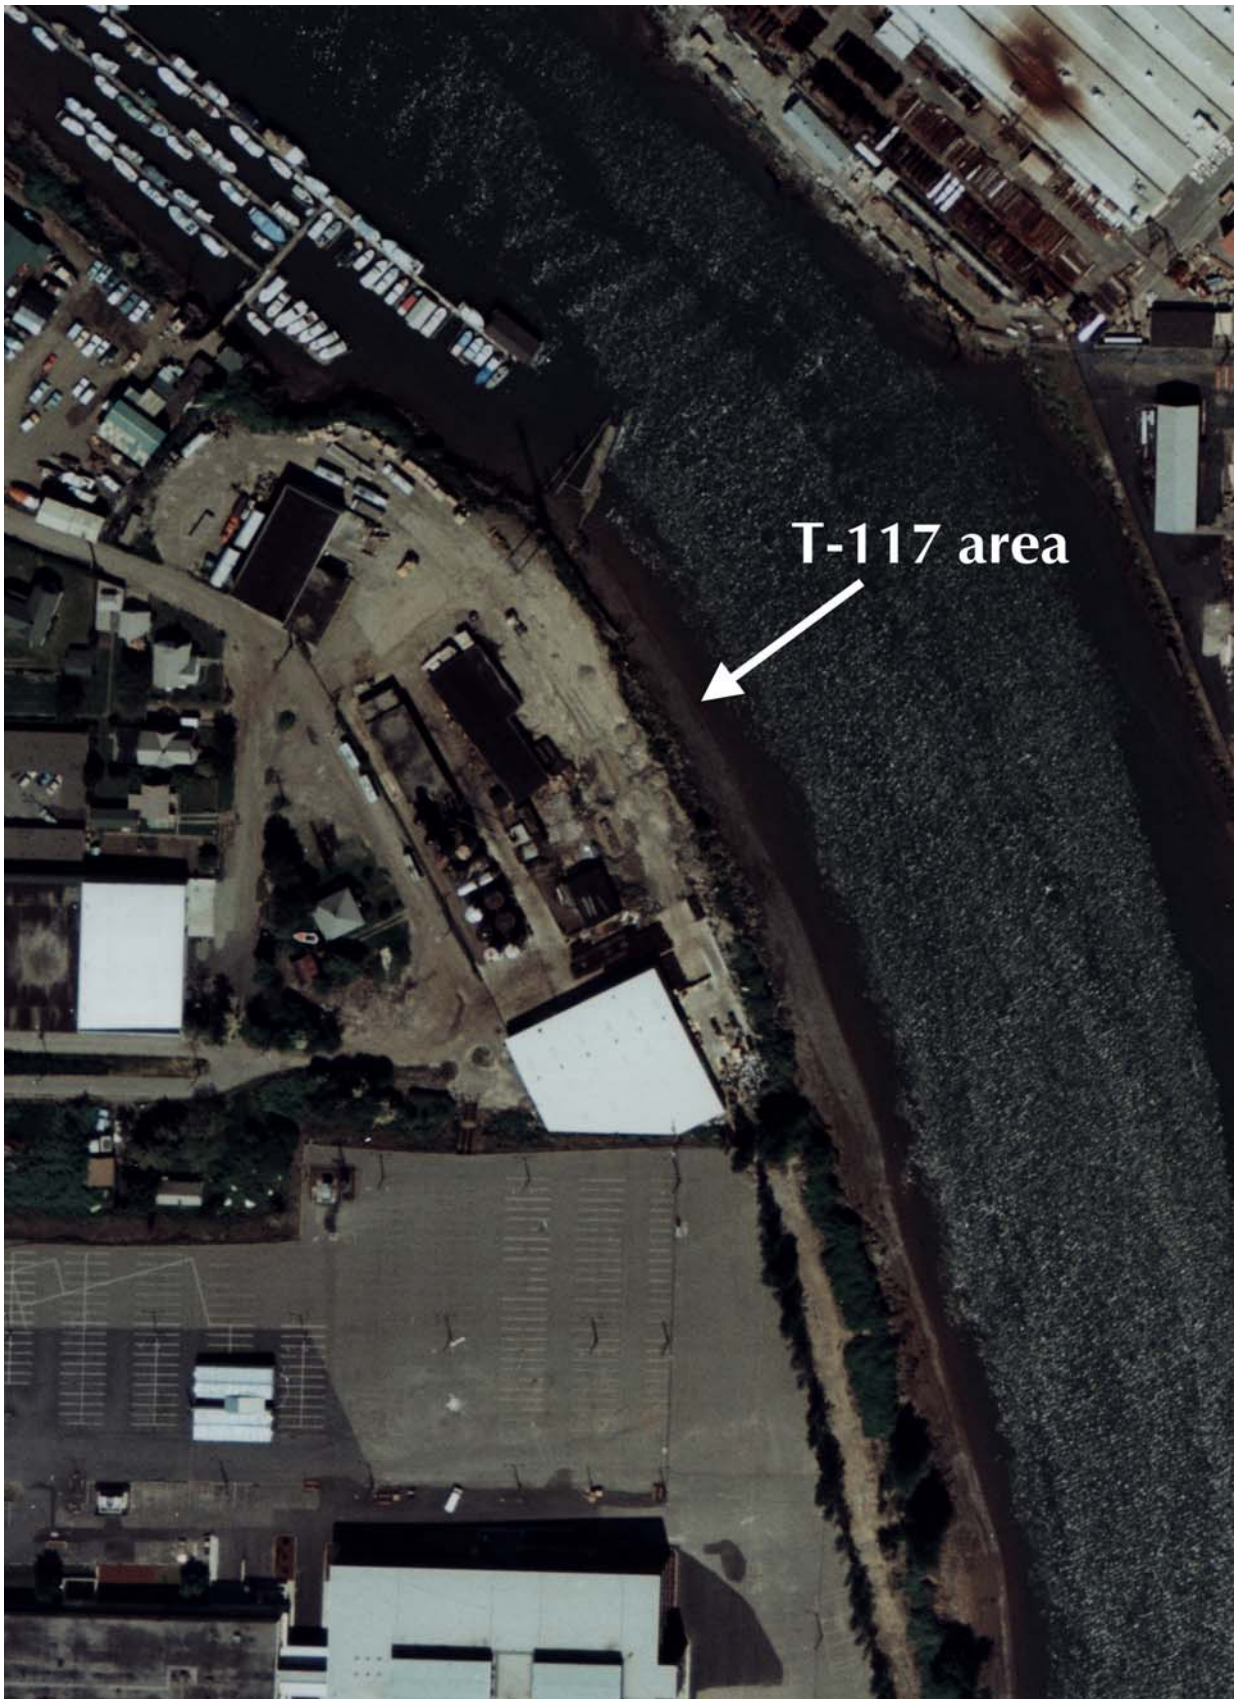
1980

The south metal building at the south end of the T-117 vicinity is in place. The Basin oil vicinity is still primarily residential. The large commercial building occupied by Allied Bolt company (and eventually occupied by Fasteners Inc and then by the Seattle Chocolate Company) can be seen at the north side of Donovan St between 16th and 17th Avenues S.
